OFFICERS CLUB BUILDING No. 114

HISTORIC STRUCTURE REPORT

Sandy Hook Unit
Gateway National Recreation Area

June 2006

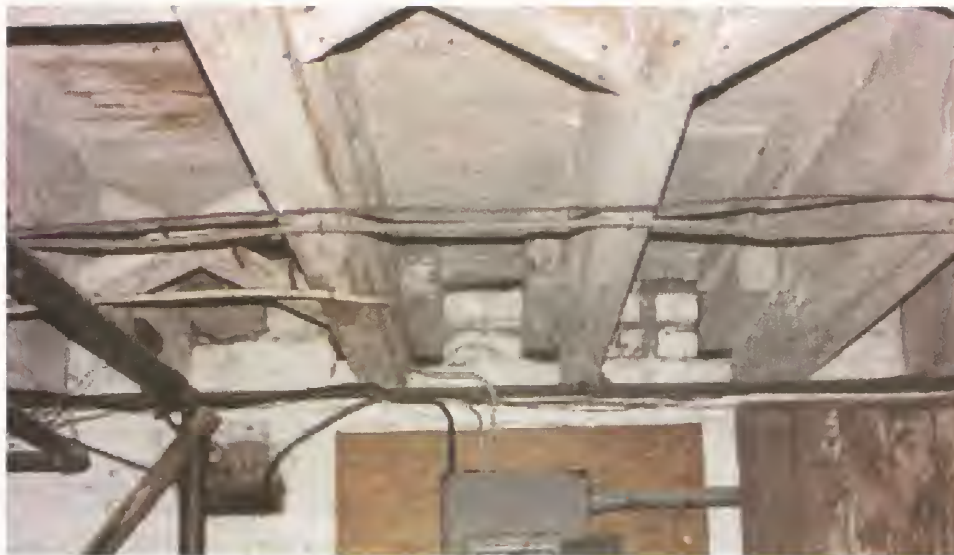
Figure 30. Officers Club, basement of rear ell, south wall, showing extant framing and brick infill that is evidence of earlier opening, 2005.

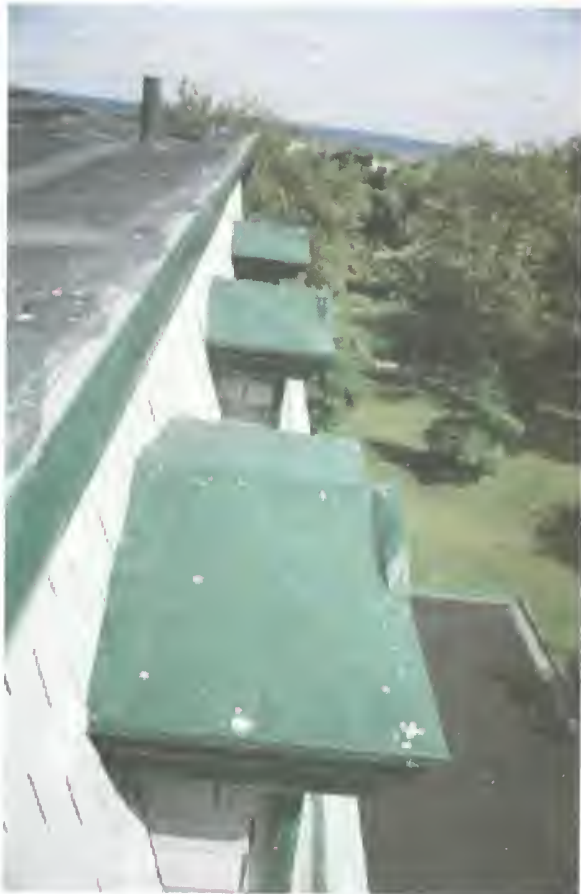
Figure 33. Officers Club, mansard roof, dormer roofing material, 1992.

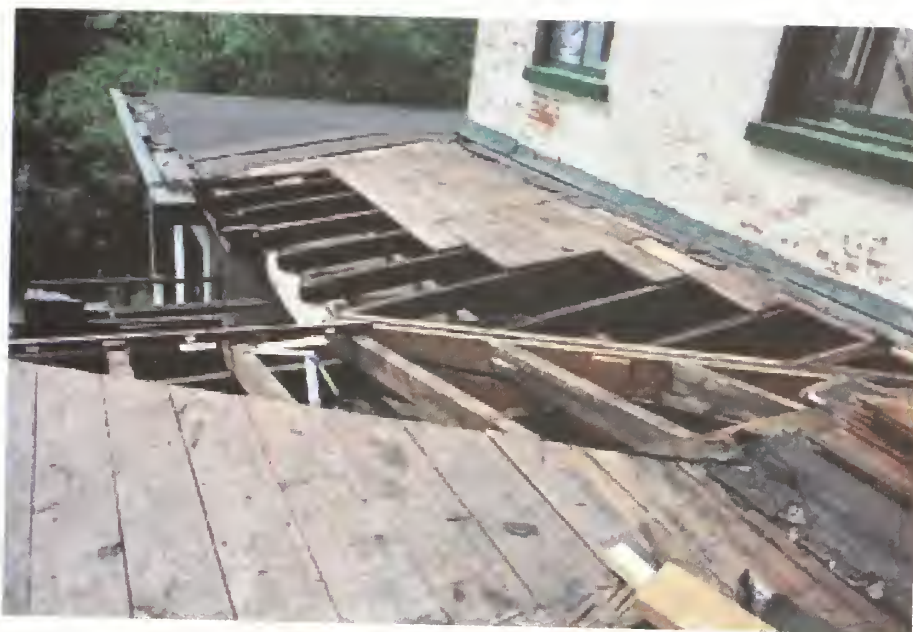
Figure 34. Officers Club, east façade, piazza roof, showing original framing and repairs, 1991.

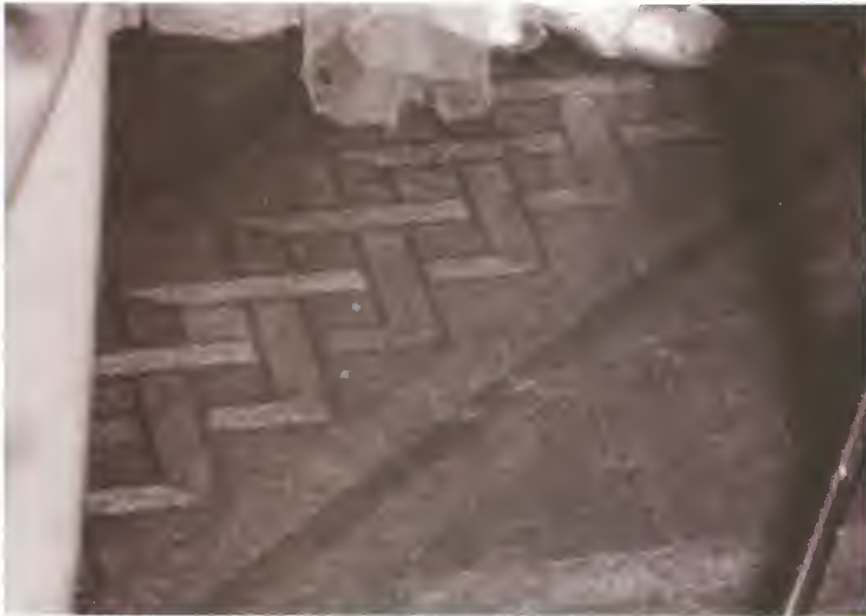
Figure 42. Officers Club, Men's Lounge (Room 104), detail from historic photograph showing parquetry floor no longer extant, ca. 1942.

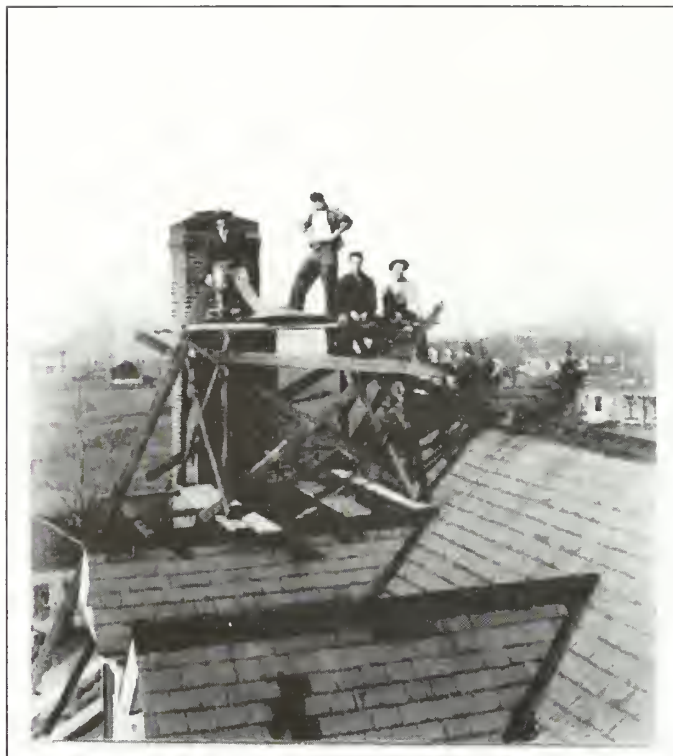
Figure 67. Officers Club, chimney work on rear- ell gable roof, ca. 1937.
